Field Safety Notice

HCM FSN 001

Notice of upgrade work required to Handicare (HCM) Trophy Scooters

UPGRADE/REPLACEMENT OF TROPHY MOTOR CONTROLLER INTERFACE

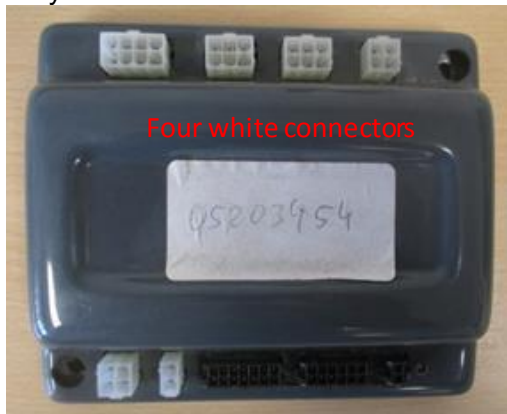
Grey Cover

As part of our on-going product testing and evaluation, we have identified a potential problem with the lifetime durability of the motor controller interface affecting units within the serial number ranges noted above. Over time the motor controller interface may degrade through the ingress of moisture and dirt and in some circumstance this has the potential to overheat leading to the possibility of injury occurring.

The affected motor controller interfaces can be identified by:

If, during the recommended annual maintenance of the scooter in the production range described above, you see evidence of the ingress of either moisture and or dirt contamination of the motor controller interface, or the slightest signs of internal heat marks on or in the motor controller interface, please exchange the affected motor controller interface for the available new version (Item No. 1018560).

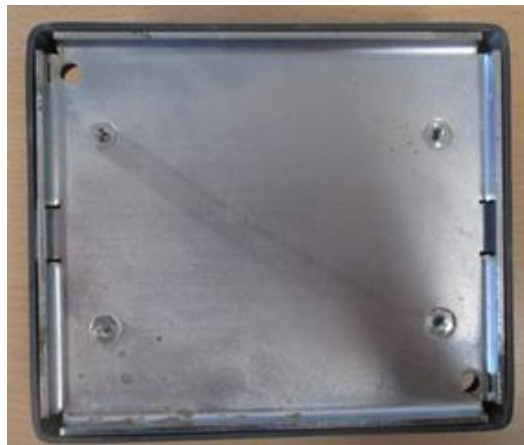
- Metal Base
- One side with 4 white connectors
