## BULLETIN DETAILS

<b>Product Group:</b>	Power
<b>Model Effected:</b>	Tango
<b>Effective Date: 30-04-2015</b>	<b>Serial No. Effective From:</b> N/A
<b>Bulletin Subject:</b>	Tango Tilt Creep switch mounting assembly

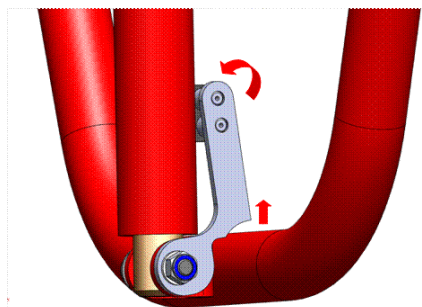
Original design

Through our feedback management system, we have received information that the material of the 034186 Tango Tilt microswitch mounting assembly (Aluminium) is not strong enough to fulfil the function adequately. It was deforming too easily, and the Tilt creep operation was not reliable enough. As a result the material was changed from aluminium to steel.

Also, part of the feedback was that the design of the assembly required a change in its geometry. When mounted on the chair, it was only touching the tube and there was the risk that it could rotate.

Material changes from aluminium to steel.

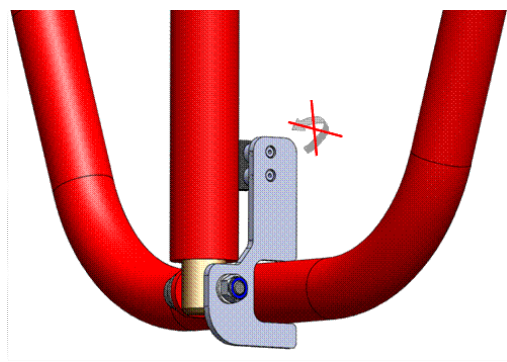
New Design

In addition the geometry of 034187 (Metal switch receiver plate) has been changed to have a 180° hugging part, to prevent rotation, and it will be square shaped and wider to prevent bending.

The part number remains the same on all spares manuals, and the new part is a direct replacement for the older style going forward. Additionally, there is another small shape update to the design which is being implemented in November 2015. Again, all part numbers will remain the same.
